IKT-LinerReport 2009

Quantum leap in waterproofing

Pipe liners now average low fault rates. In particular in the area of impermeability, significant improvements have been achieved. Inner foils can make an important contribution.

This sixth LinerReport of the IKT – Institut für Unterirdische Infrastruktur (Institute for Underground Infrastructure) is based on some 1,200 pipe liner samples that were taken at construction sites in 2009. They have inspected in the IKT testing laboratory for pipe liners. The individual results are summarised here in an overall overview.

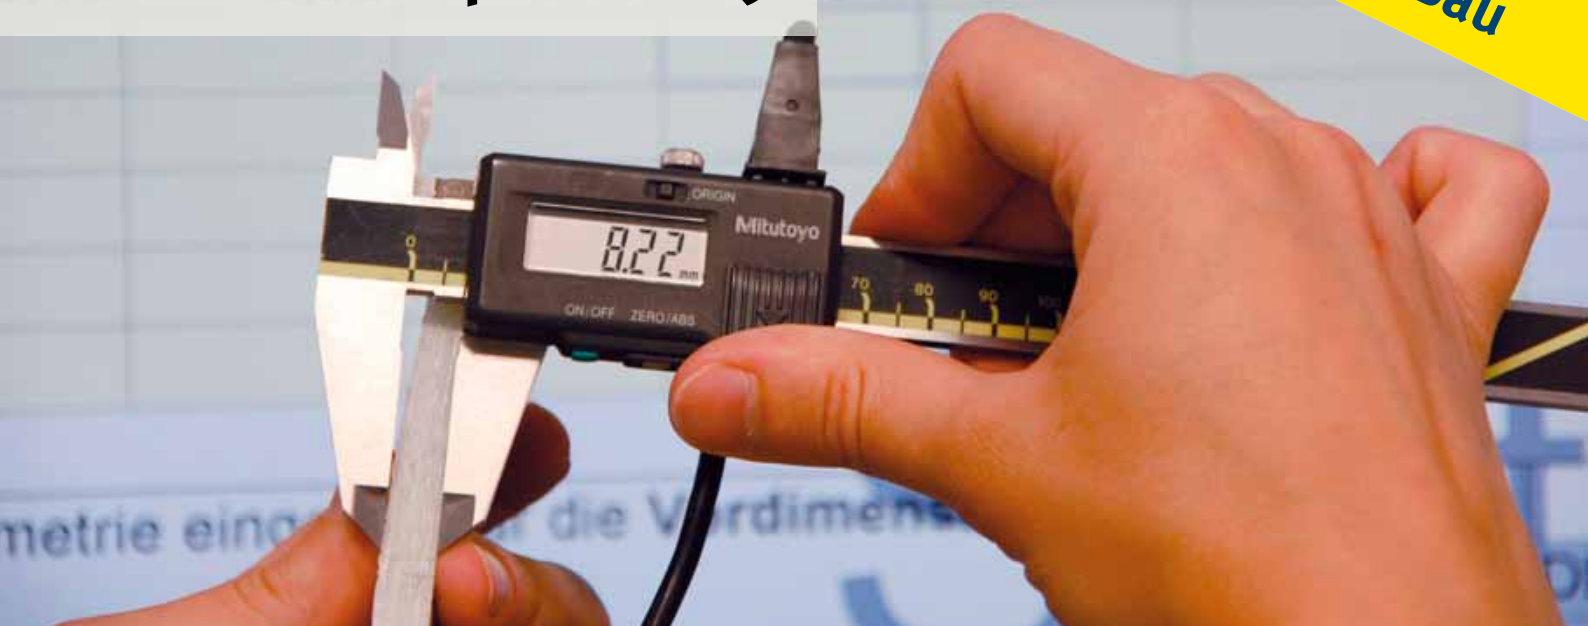
No leaks thanks to the inner foil:

The liner wall thickness is measured with precise callipers

- The minimum value is determined in the stress analysis
- Wall thickness and modulus of elasticity together determine the stiffness of the liner
- Insufficient wall thickness can compromise structural integrity
- Testing methods: with precision callipers, the average composite thickness is measured according to DIN EN 13566-4

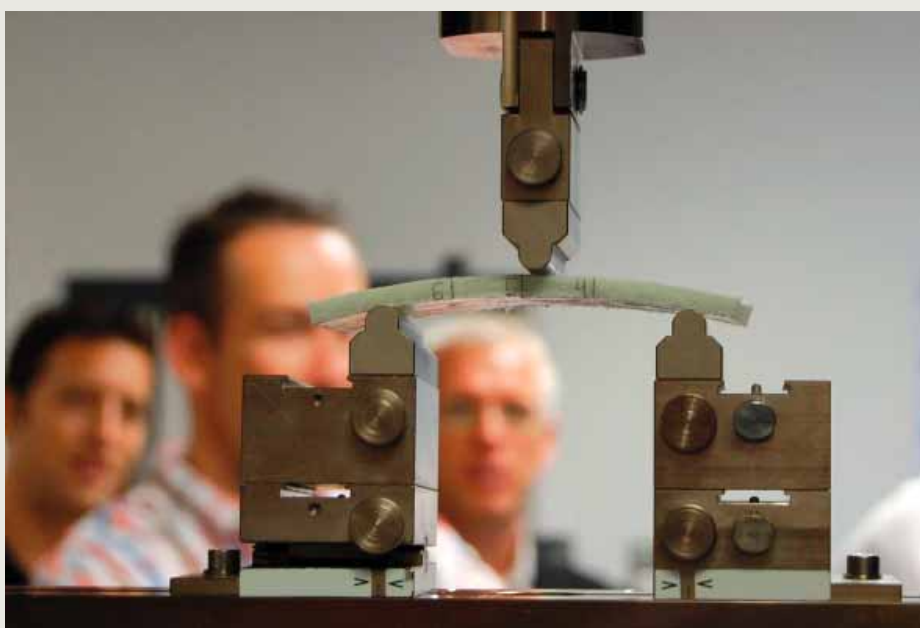
Pipe liner test in IKT

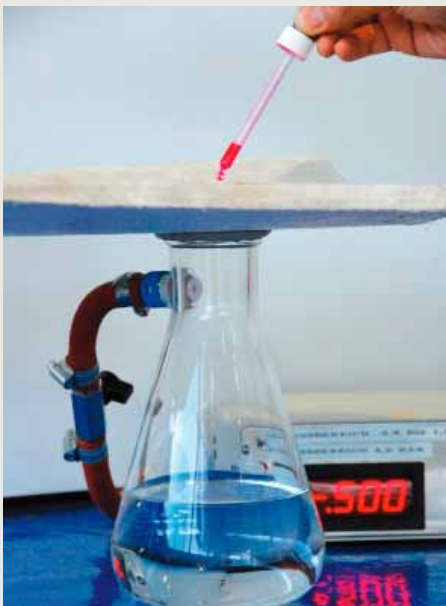
Leakage test: Red coloured water is applied to the inner side of the liner

- Cut into inner foil as long as it is not an integral part of the liner; remove outer foil if there is one
- Apply red coloured water to the inside
- Apply 0.5 bar of underpressure
- Liner is leaky if water penetrates
- Duration of the test: 30 min

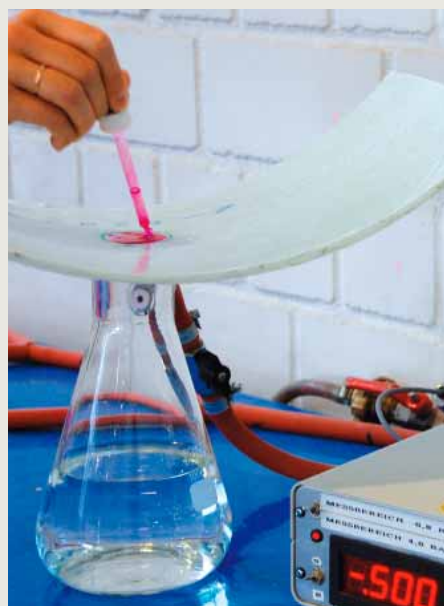
Leakage test: impermeable liner

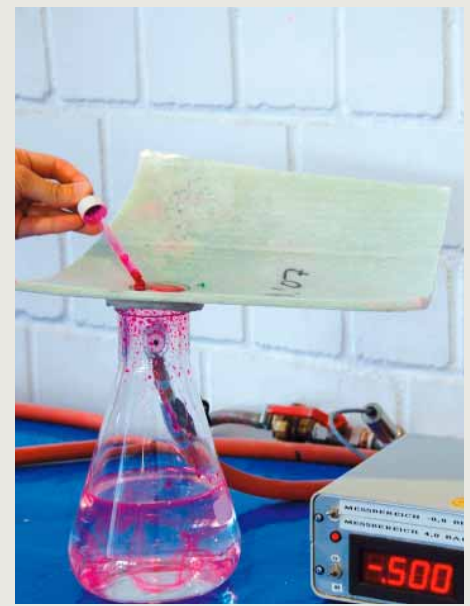
Leakage test: leaky liner
