IKT-LinerReport 2007

Tube liner quality in 2007:

**An improvement
over last year**

**BY ROLAND W. WANIEK
AND DIETER HOMANN***

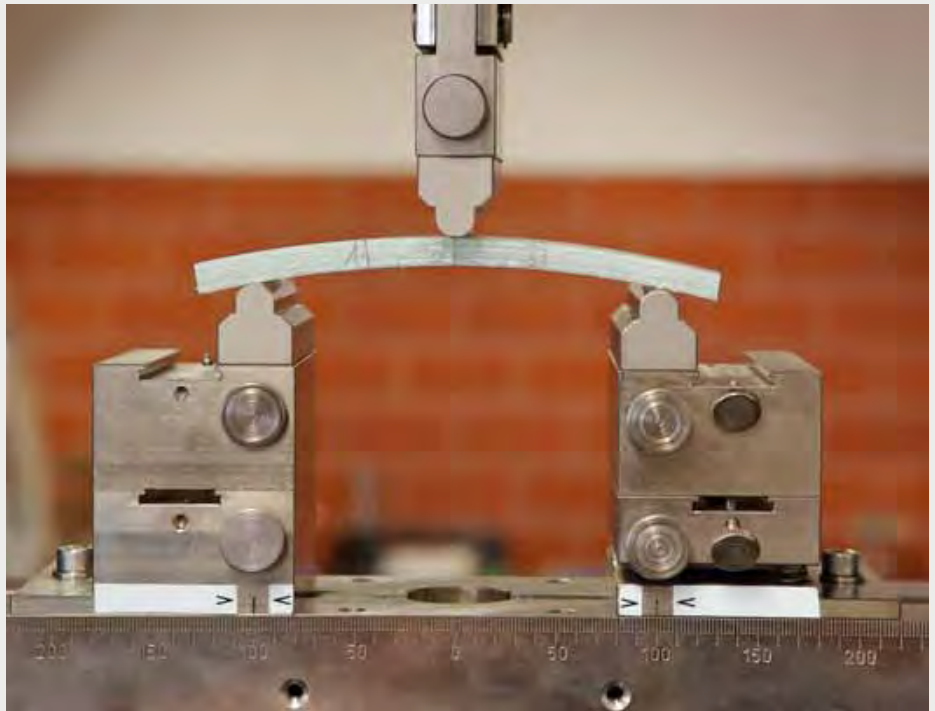
Figure 1: Liner sample undergoing the three-point bendig test

- Tube liners must be capable of withstanding loads such as those arising from groundwater, road traffic and soil pressure, for example
- The modulus of elasticity is an indicator of load-bearing capability
- If it is too low, stability may be endangered
- Test method: Three-point bending test as per DIN EN ISO 178 and DIN EN 13 566, Part 4
- Results: see Table 2

- This indicates the point at which the liner fails due to excessively high stress
- If bending strength is too low, the liner may fracture before the permissible deformation is reached
- Test method: Increase of load up to failure in the three-point bending test; as per DIN EN ISO 178 and DIN EN 13 566, Part 4 (short-term flexural strength)
- Results: see Table 3

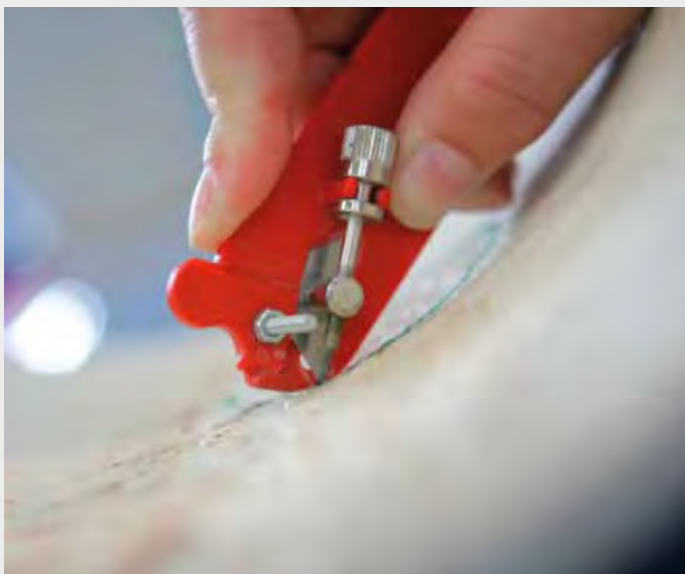
Figure 2: Cut made into inner film, with limitation of cut depth

- Cut is made into inner film and the outer film (if any) is removed
- Water containing a red dye is applied internally
- A 0.5 bar (7.25 psi) partial vacuum is applied externally
- The liner is „Not tight“ if water penetrates through
- Test period: 30 min.
- Results: see Table 5

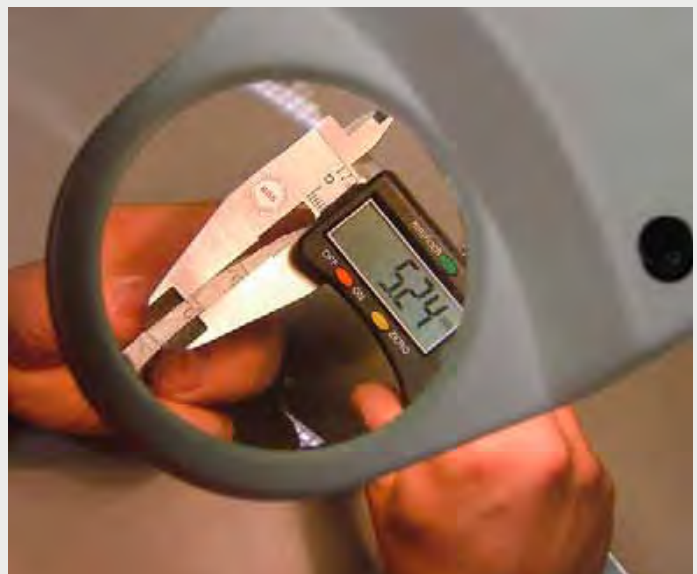
Figure 3: Measurement of liner-wall thickness

- Minimum value is specified in the stress analysis calculation
- Wall thickness and modulus of elasticity jointly determine the stiffness of the liners
- Excessively low wall thickness can endanger stability
- Test method: Mean combined thickness is measured in accordance with DIN EN 13 566, Part 4, using a precision slide gauge
- Results: see Table 4

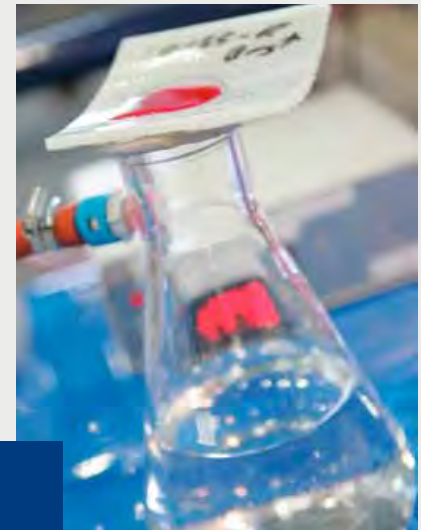
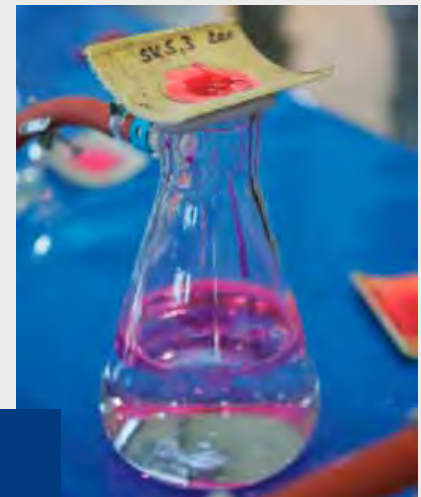
tight

not tight

Figure 4: Tightness test
