**IKT-LinerReport 2008**

# Tube liner quality: Variegated trend

Tube liners improved on a broad front in 2007, whereas 2008 has brought both advances and retreats. Where are the potentials for improvement in individual liner systems?

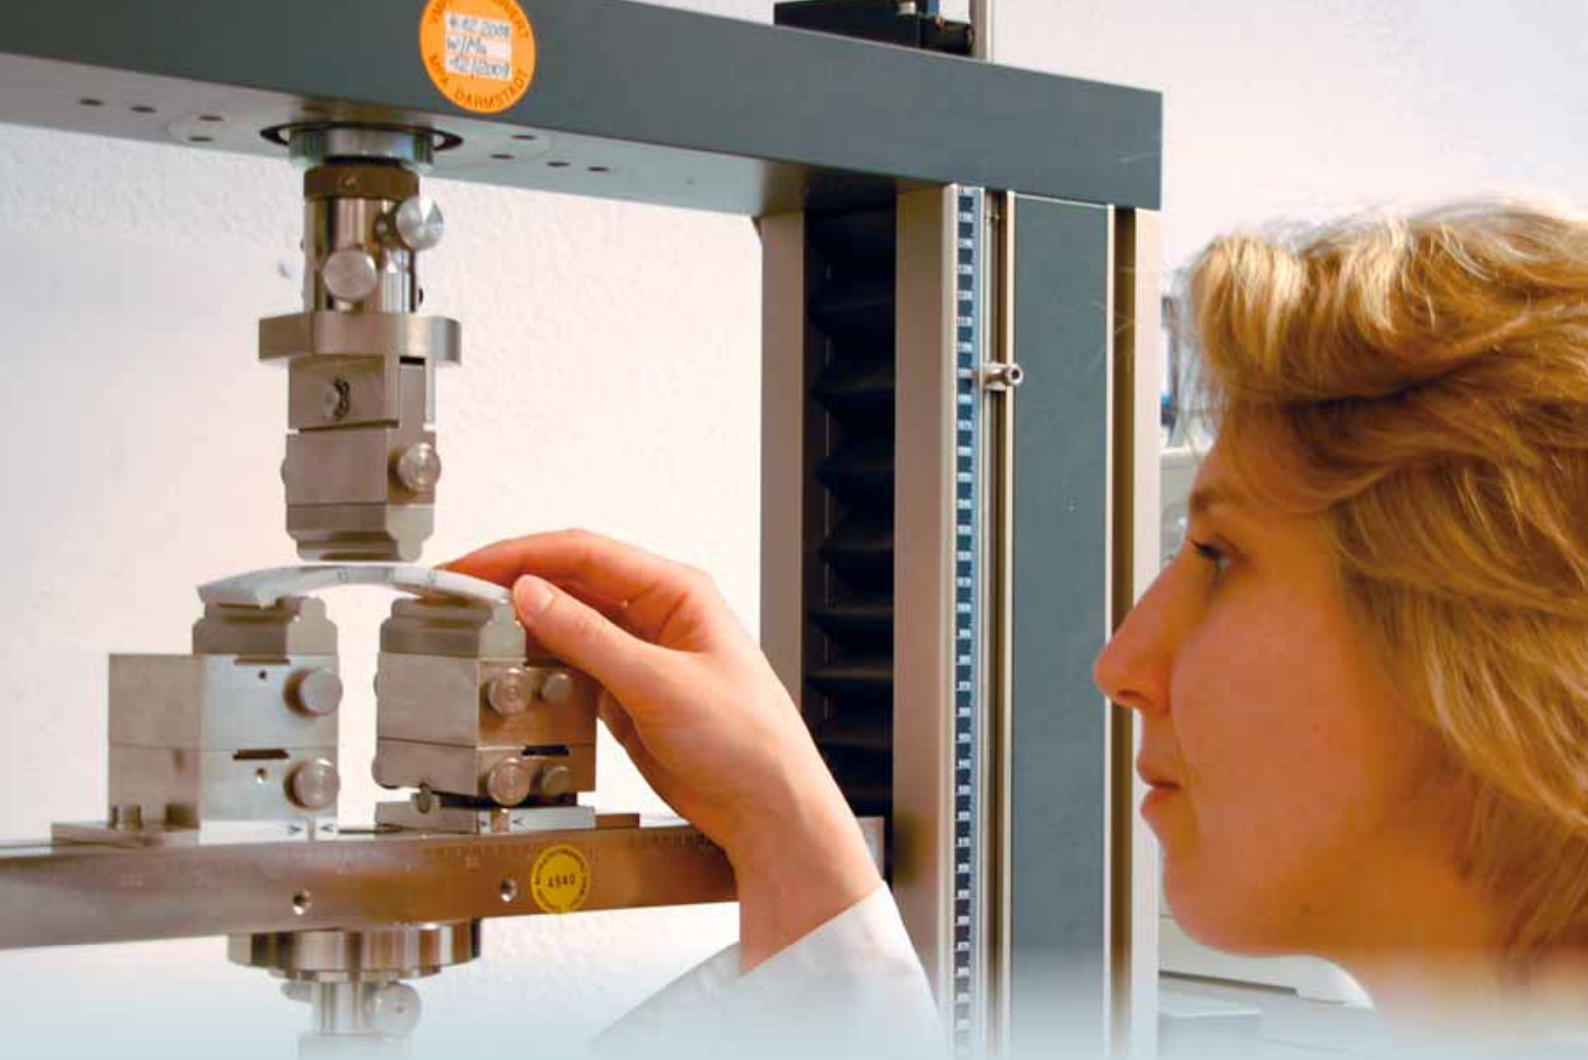
Test engineer Tatjana Kijan preparing a three-point bending test

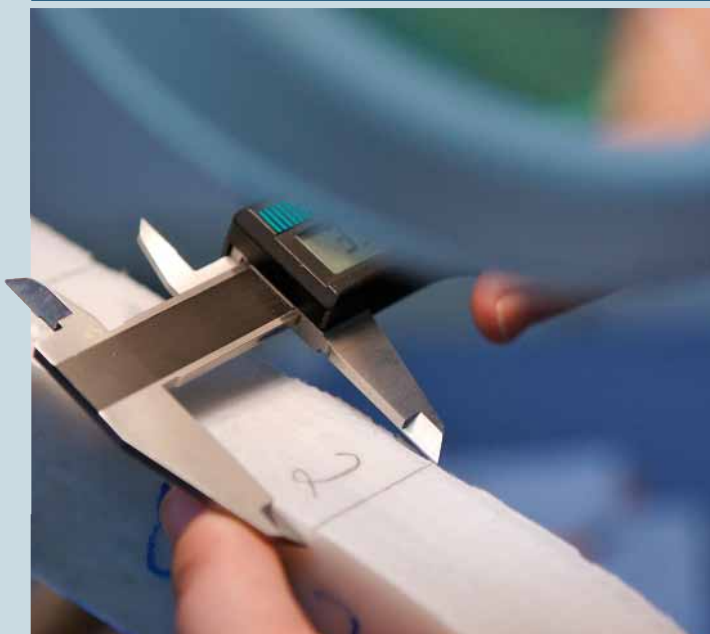
Liner wall-thickness is measured using a precision slide caliper gauge

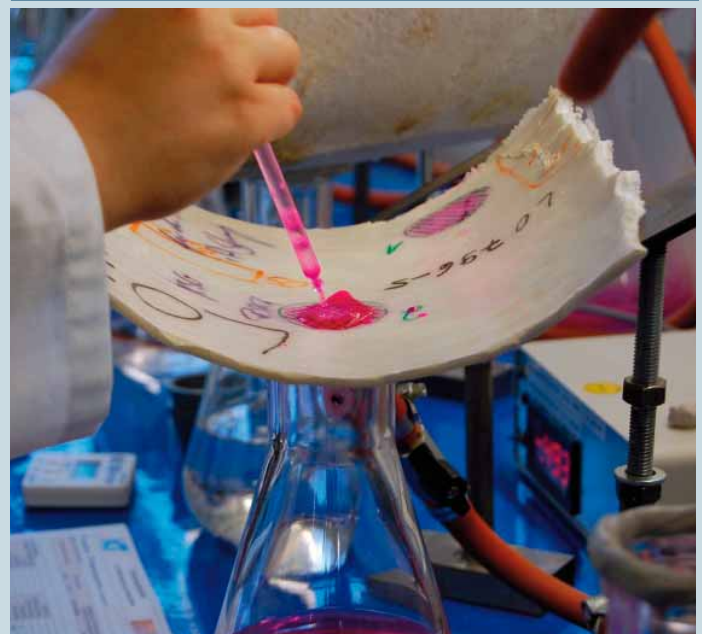
Tightness testing: water containing a red dye is applied to the inner side of the liner

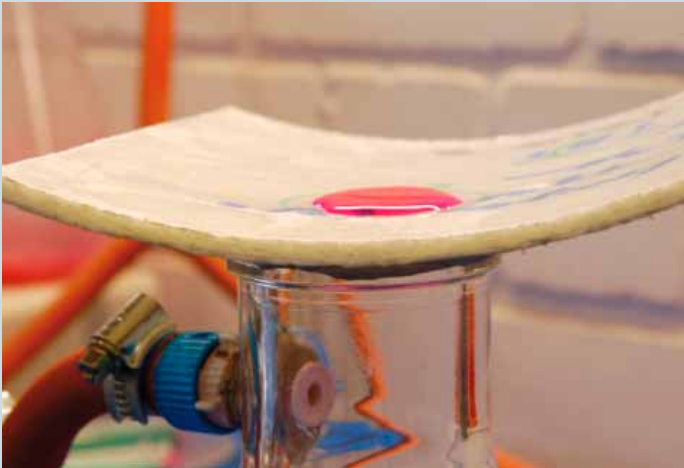
Tightness testing: liner tight

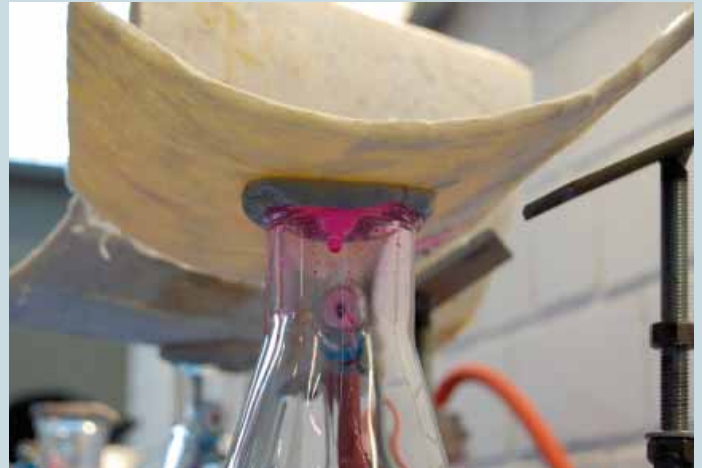
Tightness testing: liner not tight
