**IKT-LinerReport 2007**

**Tube liner quality in 2007:**

**An improvement  
over last year**

**BY ROLAND W. WANIEK  
AND DIETER HOMANN\***

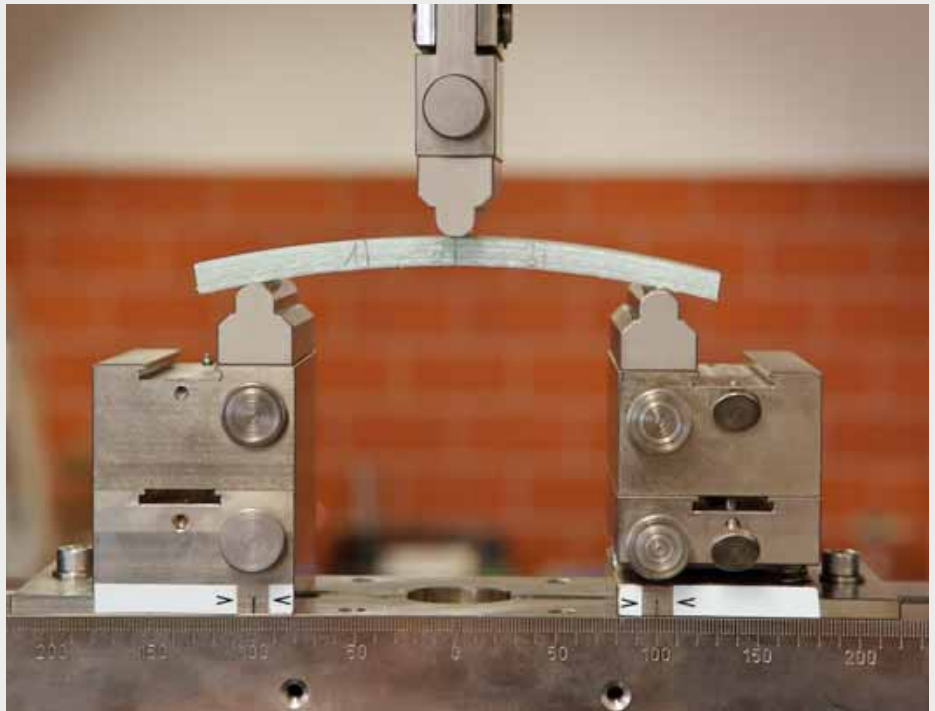
Figure 1: Liner sample undergoing the three-point bendig test

- Tube liners must be capable of withstanding loads such as those arising from groundwater, road traffic and soil pressure, for example
- The modulus of elasticity is an indicator of load-bearing capability
- If it is too low, stability may be endangered
- Test method: Three-point bending test as per DIN EN ISO 178 and DIN EN 13 566, Part 4
- Results: see Table 2

- This indicates the point at which the liner fails due to excessively high stress
- If bending strength is too low, the liner may fracture before the permissible deformation is reached
- Test method: Increase of load up to failure in the three-point bending test; as per DIN EN ISO 178 and DIN EN 13 566, Part 4 (short-term flexural strength)
- Results: see Table 3

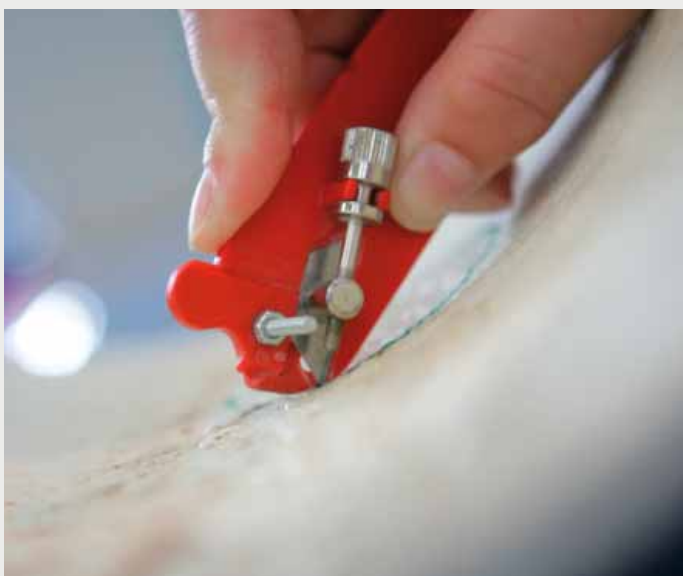
Figure 2: Cut made into inner film, with limitation of cut depth

- Cut is made into inner film and the outer film (if any) is removed
- Water containing a red dye is applied internally
- A 0.5 bar (7.25 psi) partial vacuum is applied externally
- The liner is „Not tight“ if water penetrates through
- Test period: 30 min.
- Results: see Table 5

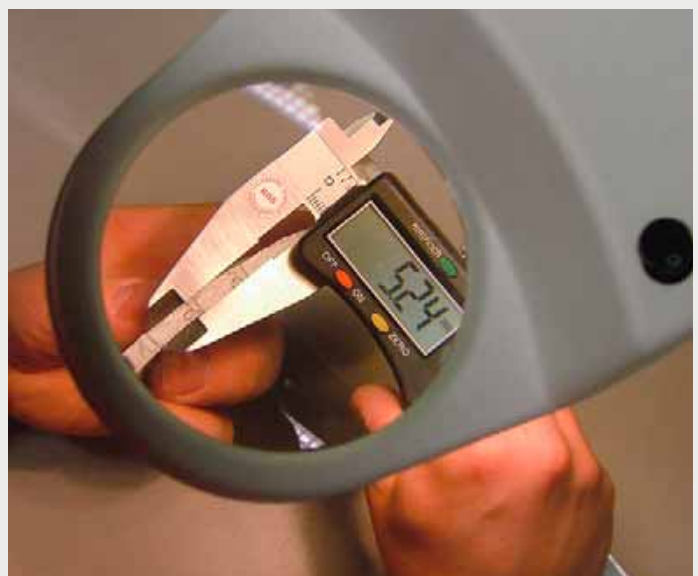
Figure 3: Measurement of liner-wall thickness

- Minimum value is specified in the stress analysis calculation
- Wall thickness and modulus of elasticity jointly determine the stiffness of the liners
- Excessively low wall thickness can endanger stability
- Test method: Mean combined thickness is measured in accordance with DIN EN 13 566, Part 4, using a precision slide gauge
- Results: see Table 4

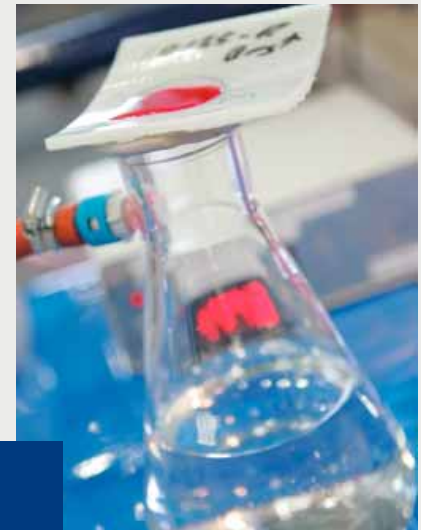
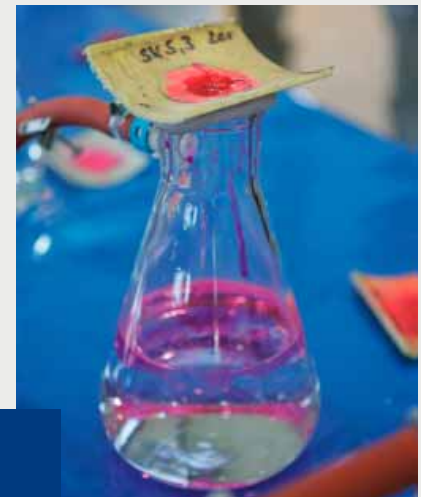
**Figure 4: Tightness test****Table 6: Test results classified by liner types**
